ANALYSIS OF DAMAGE DATA COLLECTED FOR WINE STORAGE TANKS FOLLOWING THE 2013 AND 2016 NEW ZEALAND EARTHQUAKES

ABSTRACT

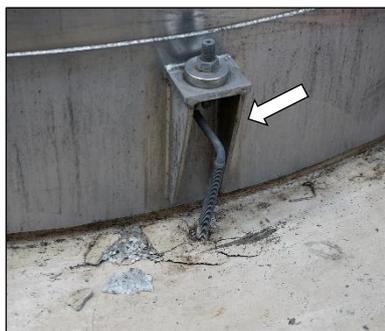
A vast majority of the anchors having earthquake-related damage (94%) in the 2016 earthquake required replacement (see Figure 12a,b). Bolt buckling (see Figure 3a) and bolt elongation (see Figure 3d) were the most common types of failure mode observed in both the 2013 and 2016 earthquakes.

(a) Bolt buckling:
6.1% in 2016

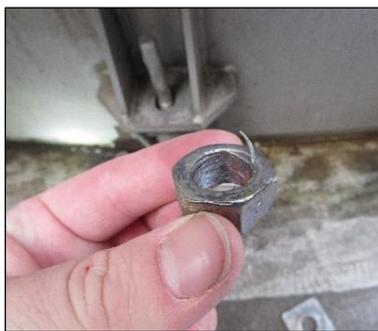
(b) Thread shearing:
7.5% in 2013 (4.0% in 2016)

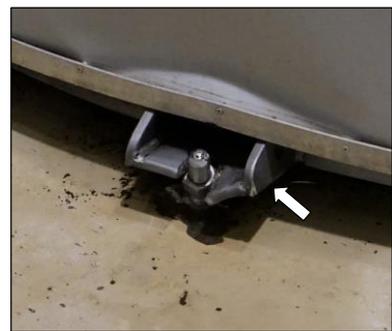
(c) Bracket failure:
1.0% in 2016

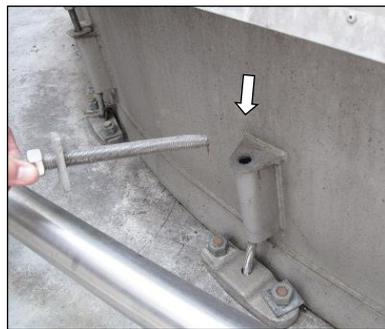
(d) Bolt elongation:
7.4% in 2016

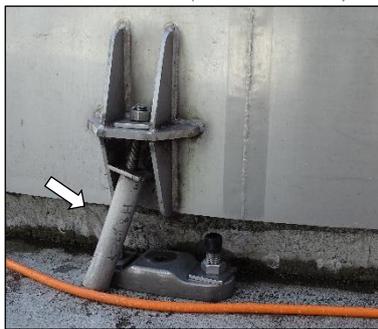
(e) Displaced anchor:
1.0% in 2016

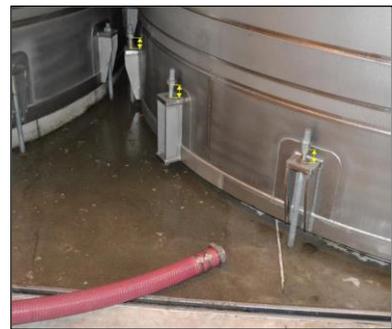
(f) Tank settlement:
20.0% in 2013

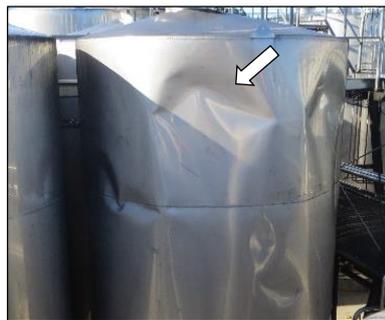
(g) Barrel other:
2.6% in 2013 (14.7% in 2016)

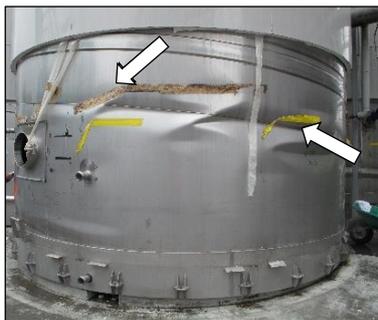
(h) Diamond shaped buckling:
1.0% in 2013 (6.1% in 2016)

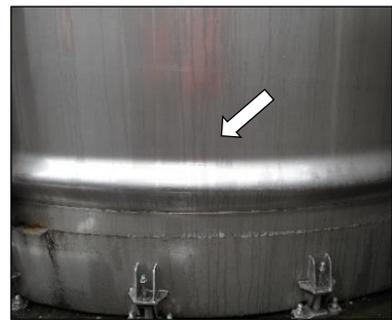
Elephant-foot buckling (see Figure 3i) generally occurs in tanks that are mostly fully filled, is an elastic-plastic type of instability [43], [46], [16], and can be described as an outward bulge of the tank wall shell, whereas diamond shaped buckling (see Figure 3h) is a type of elastic instability [43], [46], [16]. Sobhan et al. [46] stated that elephant-foot buckling of the steel tank wall is caused by the interaction of both circumferential tensile stress close to the yield strength and by axial compressive stress exceeding the critical stress, whilst diamond shaped buckling is caused by severe axial compressive stresses. Compared with the 2013 earthquakes, in the 2016 earthquake larger percentages of elephant foot buckling and diamond shaped buckling were observed, with earthquake elephant-foot buckling (11.0%) and diamond shaped buckling (6.1%) causing the highest percentage of severe (section replacement) damage to the barrel.

(i) Elephant foot buckling:
6.2% in 2013 (11.0% in 2016)

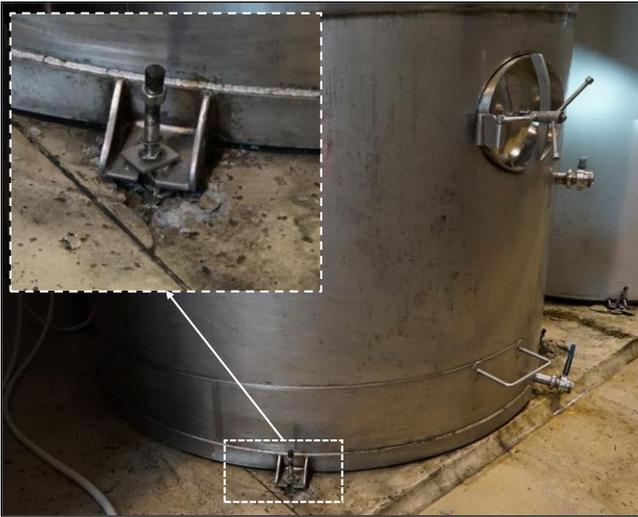
(a) Loose bolt due to seismic loads with minor damage to concrete slab

Figure 7: Damaged 25 kL flat-based wine tanks due to simplicity of the anchorage system.

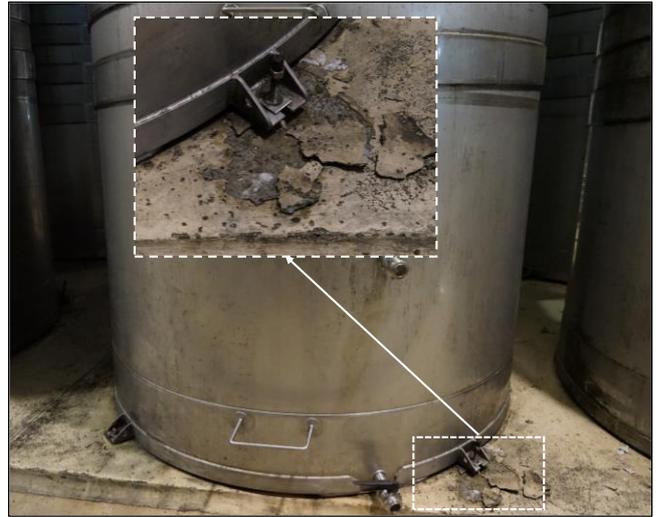
(b) Loose bolt resulted in severe damage to concrete slab

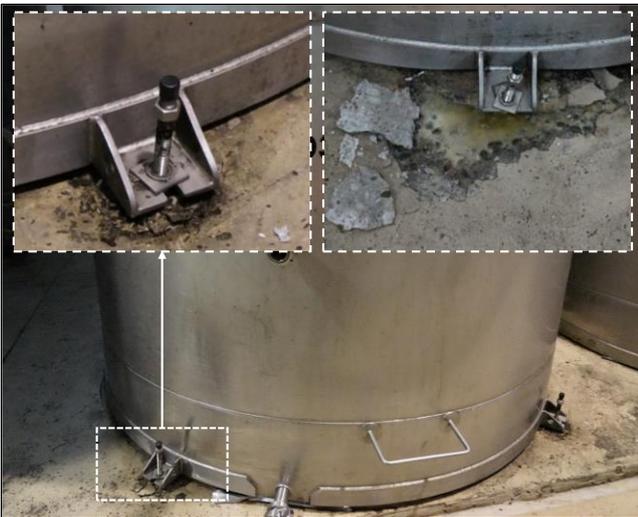
(c) One loose bolt resulted in damage to the concrete slab and the other loose bolt caused no visible damage to the concrete slab

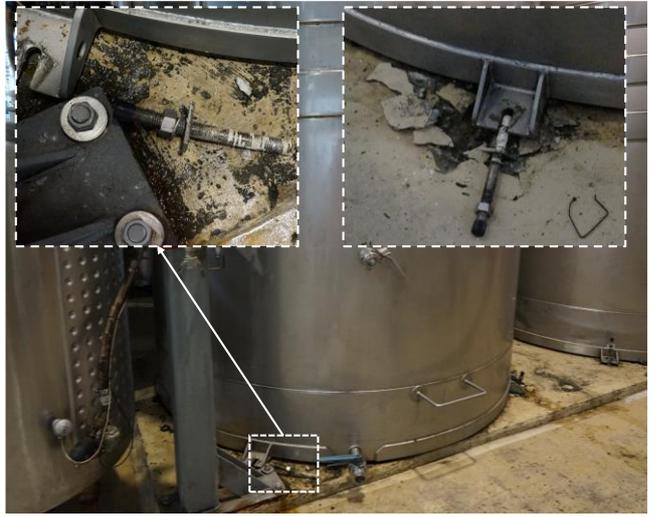
(d) Anchor pull-out and slab damage

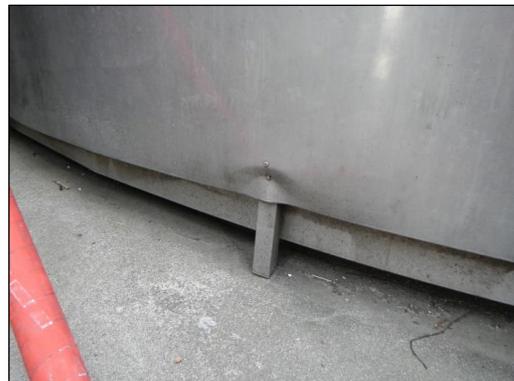
(b) Tank 400 kL- minor damage to the skirt

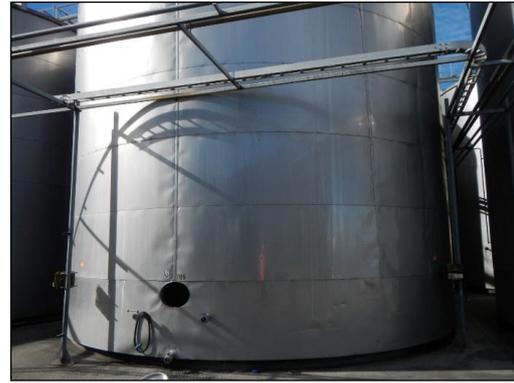
(d) 550 kL tank - minor damage to the barrel

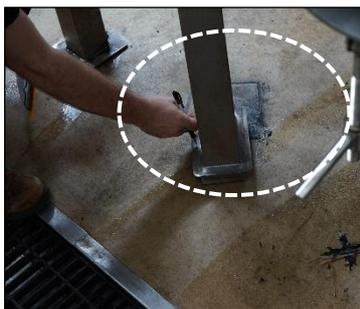
(a) Global movement: 9.3% in 2013 (2.0% in 2016)

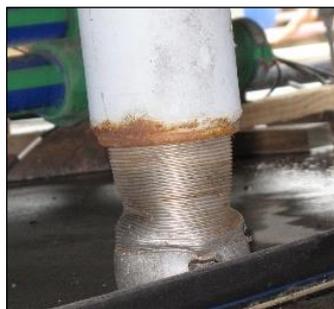
(b) Telescopic buckling: 2.8% in 2013 (<1.0% in 2016)

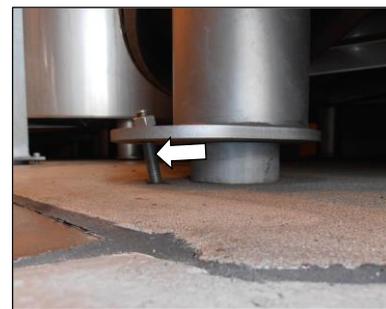
(c) Anchor bolt damage: 1.0% in 2016

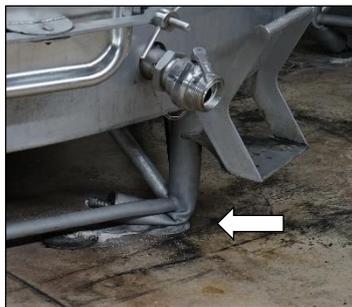
(e) Leg buckle: 18.5% in 2013 (6.7% in 2016)

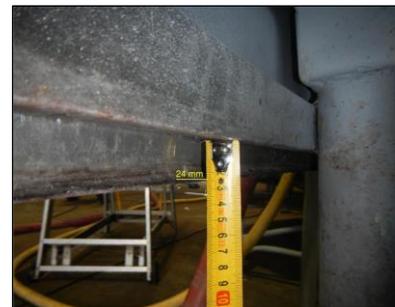
(f) Legged tank settlement: Less than 1% in 2013

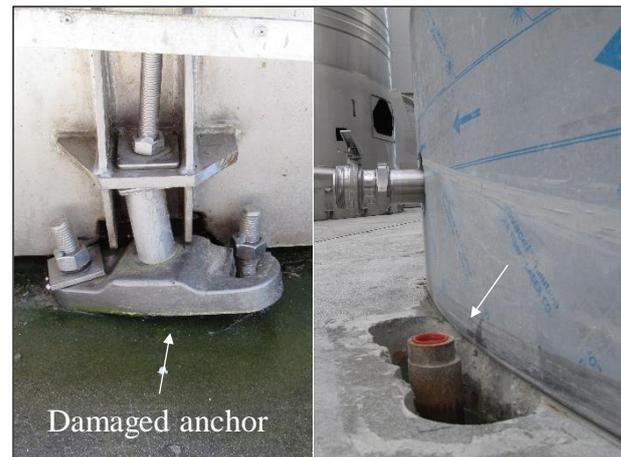
(b) Damaged anchor and preparation of concrete to locate a new anchor

Figure 19: Typical examples of anchor bolt replacement.
