**Benefits of riparian planting:
A case study of lowland streams in
the Lake Ellesmere catchment**

A thesis
submitted in partial fulfilment
of the requirements for the Degree of
Master of Resource Studies

at
Lincoln University
by
Kathryn Elizabeth Collins

2011

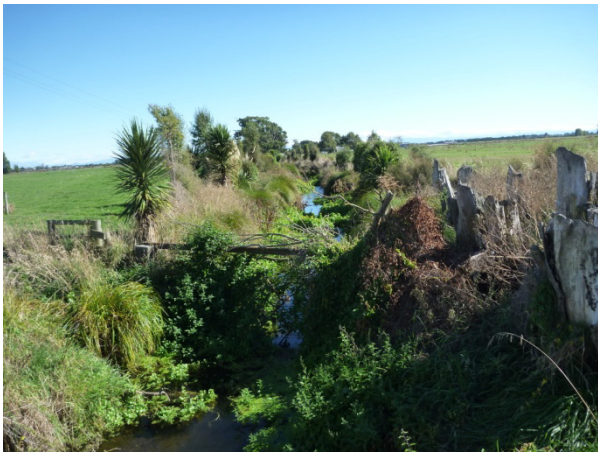
Figure 3.1: Planted buffer on Boggy Creek (paired reach 1).

The four restored sites are Boggy Creek at Volckman Road (Figure 3.1, site 1 Figure 3.5), Harts Creek downstream of The Lake Road (Figure 3.2, site 3 Figure 3.5), Harts Creek downstream of Lochheads Road (Figure 3.3, site 5 Figure 3.5) and Birdlings Brook at Beethams Road (Figure 3.4, site 7 Figure 3.5). Each of these sites have buffer zones that have been planted with native vegetation (Table 3.1). Three of the buffer zones are fenced to exclude stock, and the fourth site is not grazed (Harts Creek at Lochheads Road).

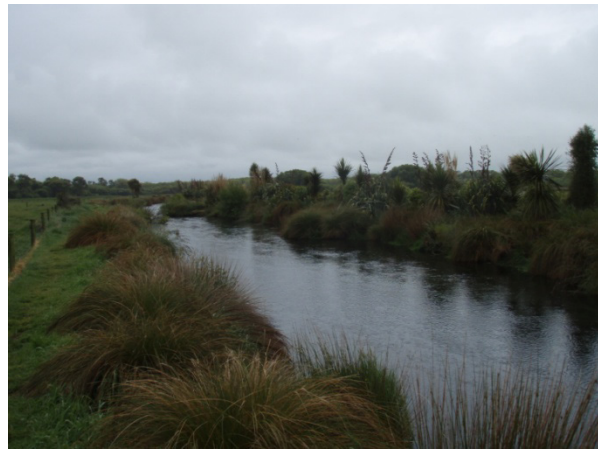
Figure 3.2: Planted buffer on Harts Creek downstream of The Lake Road (paired reach 2).

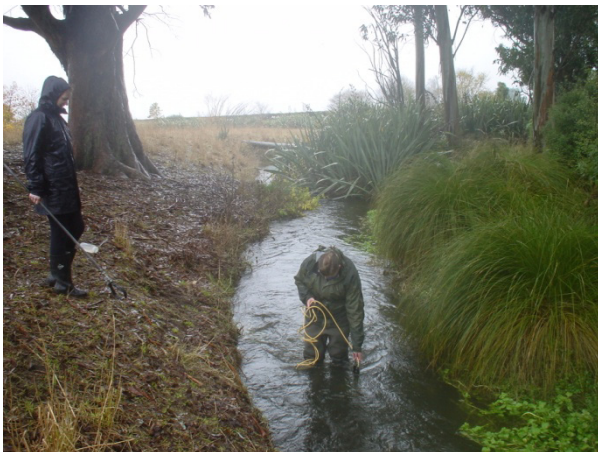
Figure 3.3: Planted buffer on Harts Creek downstream of Lochheads Road (paired reach 3).
Photo courtesy of Hamish Rennie.

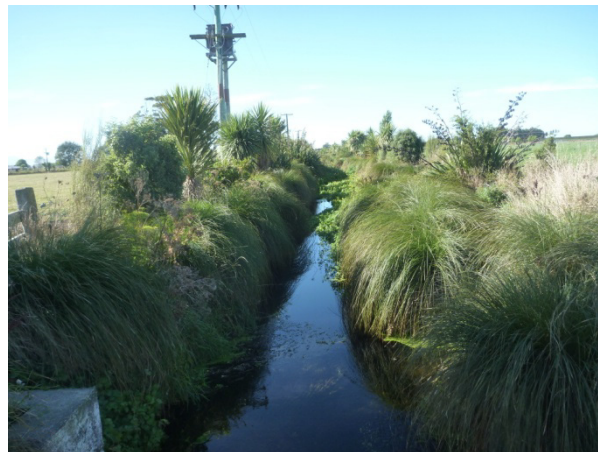
Figure 3.4: Planted buffer on Birdlings Brook (paired reach 4).

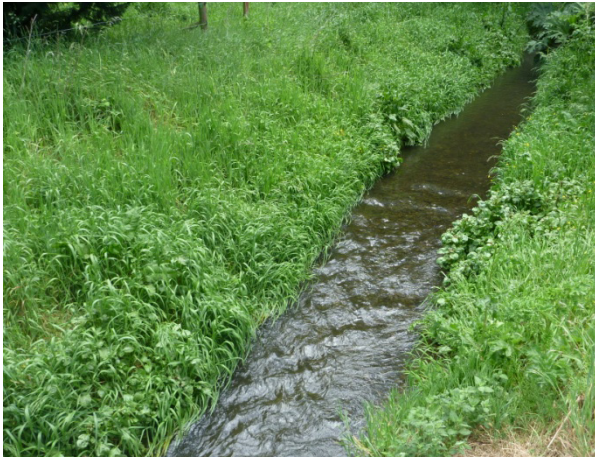
Figure 3.6: Boggy Creek control site (paired reach 1).

A paired control site was established upstream for each planted riparian area. The four paired sites are Boggy Creek at Leeston Road (Figure 3.6, site 2 Figure 3.5), Harts Creek at The Lake Road (Figure 3.7, site 4 Figure 3.5), Harts Creek upstream of Lochheads Road (Figure 3.8, site 6 Figure 3.5) and Birdlings Brook at Feredays Road (Figure 3.9, site 8 Figure 3.5). The control sites had not been planted with native vegetation. The control reaches at Boggy Creek and Birdlings Brook were fenced, but at Harts Creek – The Lake Road and Harts Creek – Lochheads Road fences were not in place. At Harts Creek – Lochheads Road the area adjacent to the stream was not actively grazed during the sampling period, while at Harts Creek – The Lake Road the paddock was actively grazed by cattle who were able to access the stream bed until a fence was constructed mid way through the sampling period in June (Figure 3.7, Figure 3.10).

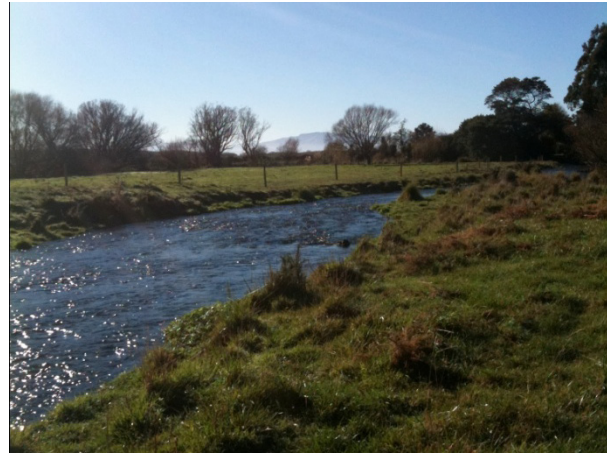
Figure 3.7: Harts Creek at The Lake Road control site (paired reach 2) in June, after a fence to exclude stock was constructed.

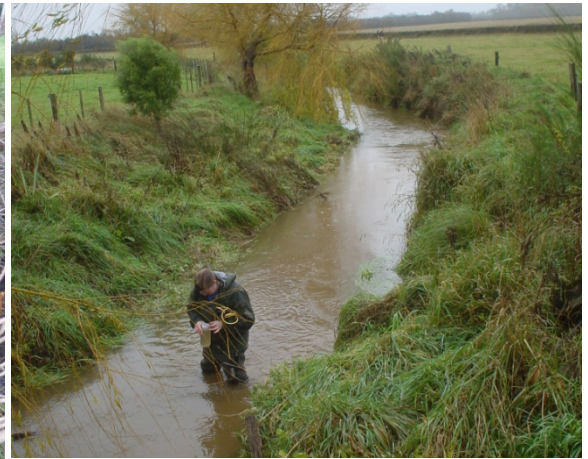
Figure 3.8: Harts Creek control site upstream of Lochheads Road (paired reach 3).

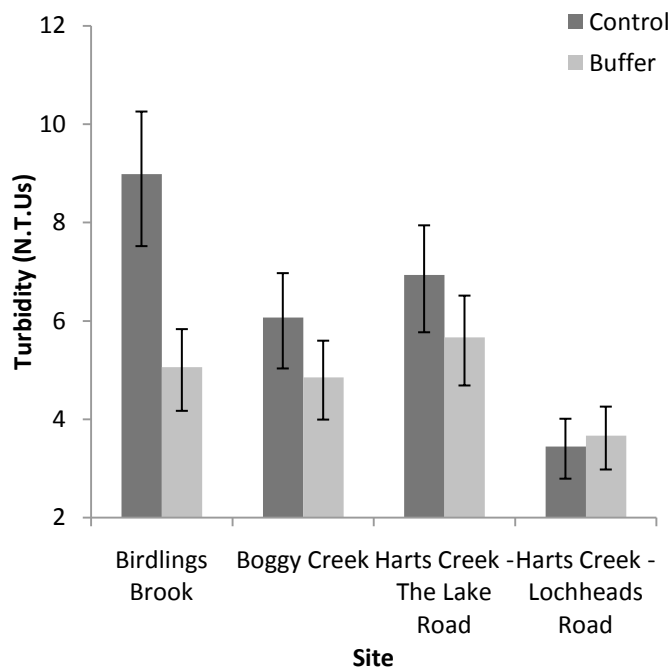
There was found to be a significant main effect of treatment, ($\chi^2 = 4.45$, DF = 1, $p = 0.044$), where turbidity was lower in planted areas. There was no effect of site ($\chi^2 = 1.75$, DF = 3, $p = 0.630$) or interaction between site and treatment ($\chi^2 = 4.06$, DF = 3, $p = 0.277$) (Figure 4.6).

Figure 4.6: Average water turbidity (\pm SEM) between control and buffer sites.
