A GIS Based Walkway Management System

Mary Avery, Ryan Clements, Glen Harrison,
Ken Hughey and Marty Thompson

Research Report No: 97/08
October 1997

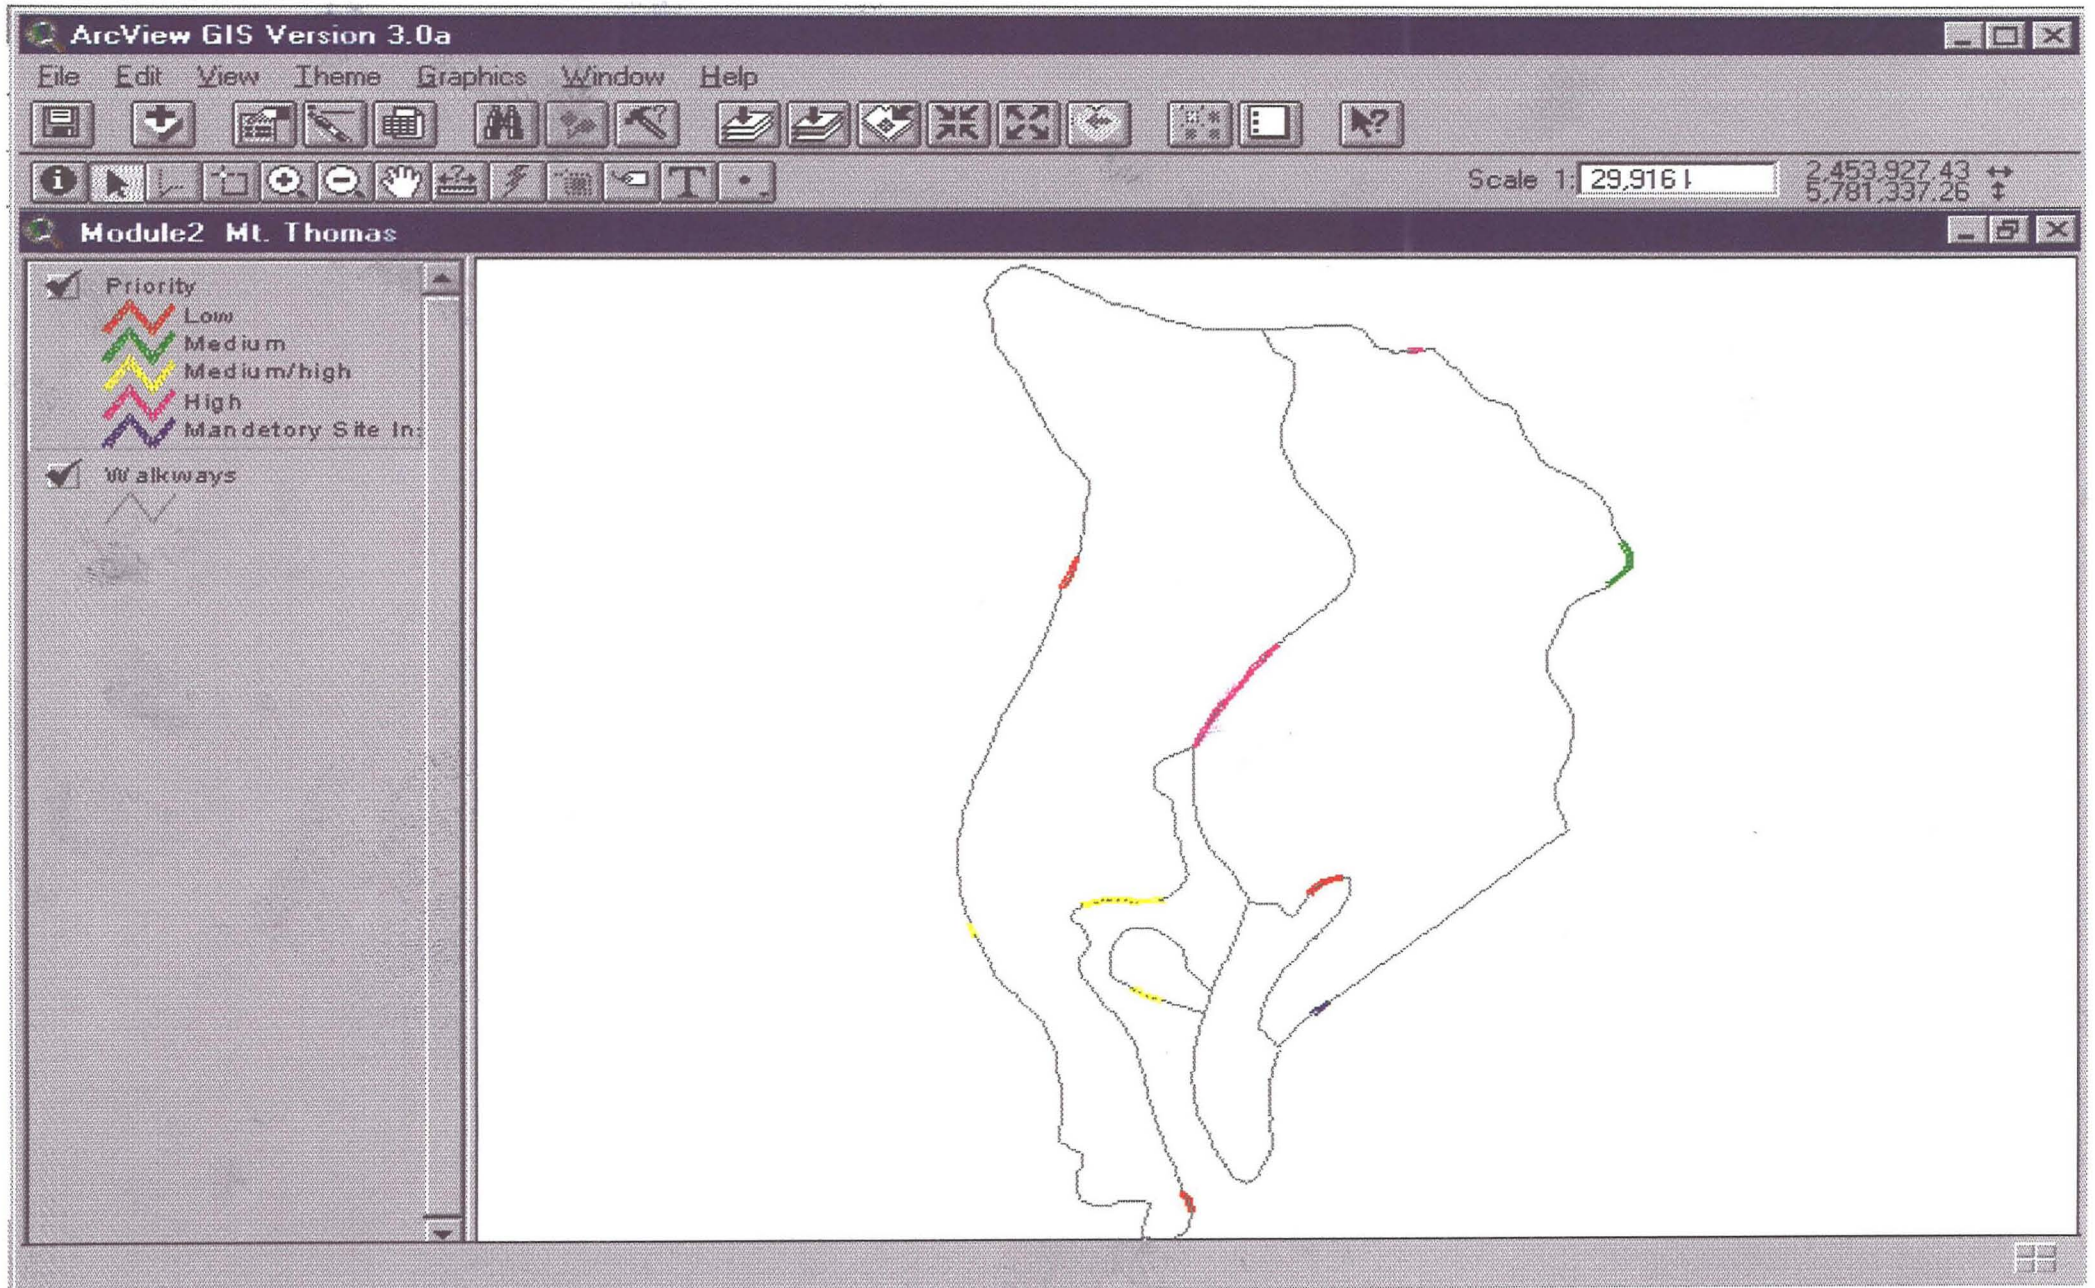
Screen 3

Module 2 displays the final priority attached to walkways with actual maintenance requirements. The walkway segments are now classified Low – Mandatory.
