DAMAGE REDUCTION METHODS OF CENTRE PIVOT IRRIGATION SYSTEMS IN WINDSTORMS

Abstract- The September and October (2013) wind storms in Canterbury, New Zealand had highest worldwide reported windstorm damaged on centre pivot irrigation systems. Around 800 centre pivot has been damaged and it cost farmers millions dollars directly and indirectly. It was very difficult to find the engineering proofed recommendation for farmers to protect their irrigation systems during windstorms. The study has developed to understand farmers' reactions, before, during and after wind storm to protect their irrigation systems. After several face to face interview and analysing 91 questionnaires, and evaluating available guidelines the best recommendations were selected to help farmers. The study shows appropriate action plan can reduce the windstorm damages significantly. The information of this study will be useful for all farmers to reduce wind storm damage on centre pivots.

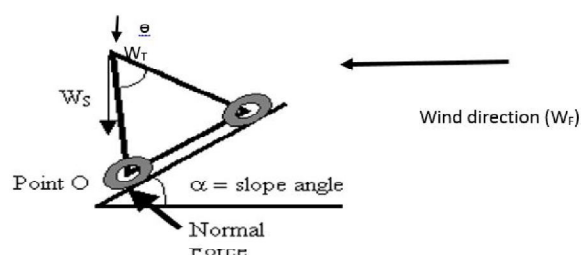
slope angle (α) (Figure 1) are other key elements which have immense impact on the stability of a centre pivot. Whether weight of the span will tip the tower at different slope angles can be determined by analysing the moment of truss weight (W_T) and the moment of span weight (W_S) about O.

Figure 1. Centre pivot at an inclined surface

For example, a pivot with a 7.26 m height tower is stable until the slope angle approaches 65 degrees. A larger central angle results in more stable towers. The height of the tower also affects the stability. However, different brands have their own recommended values for stability. For example, allowable cross-sectional inclination (between the adjacent wheels) is between 10-15% and the allowable longitudinal inclination (between two towers) is 8° for a BAUER CENTERSTAR 500 (Bauer, 2005).

the cross-sectional area of the farm is perfectly horizontal. However, if the cross-sectional area of the farm is inclined, then the additional weight caused by the water can have both positive and negative effects on the irrigator's stability. If the wind force (WF) and the resultant weight of the span (Ws) due to the irrigator being filled with water are acting in the same direction (Figure 2) then filling the irrigator with water can be very risky. The additional force due to the water will contribute to overturning the irrigator at point O and the risk of overturning increases with increasing inclination. However, if the wind force (WF) and the resulting weight of the span (Ws) are acting in the opposite direction then the additional force due to the water can be supportive to increasing the irrigator's stability.

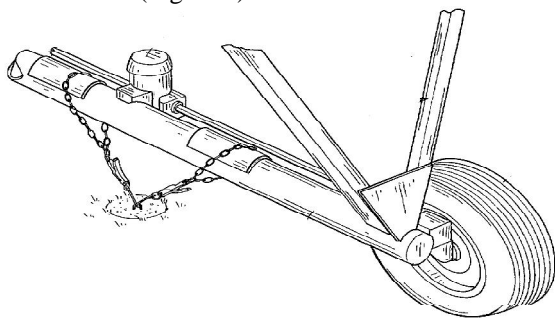
At the wheels – tying from the base beam to the ground is not very common in New Zealand. It would be the fastest way to tie the irrigators; however the force that the beam can support should be investigated carefully. We know the beams are not designed to support the anchors. The question is, is the beam strong enough and where is the best place to tie it down to (Figure 2).

Figure 2. The tie-down anchor to support span beams

Across the span – If only the wheels are tied down then the spans can still roll over in wind gusts. It will reduce the bouncing; however, in all current irrigators, there is no specific place to tie the high parts. The only places for tying would be truss rod brackets or main pipes, which need mechanical testing to find whether they can support the weight of the irrigators during windstorms and gust. If the wrong points are selected for attaching the strops, then they will be broken quickly. Estimating the strength of each truss rod bracket (in different models and brands) will help to estimate how many of them are needed to keep the span stable.
